**RADIOLOGICAL SCANNER VAN SURVEY**  
**Hunters Point Naval Shipyard**  
**California**  
**September 9-12 2002**

RE: USEPA Radiological Scanner Van Report, Hunters Point Shipyard, March 2003

## Radiological Scanner Van Survey Hunters Point Final Report

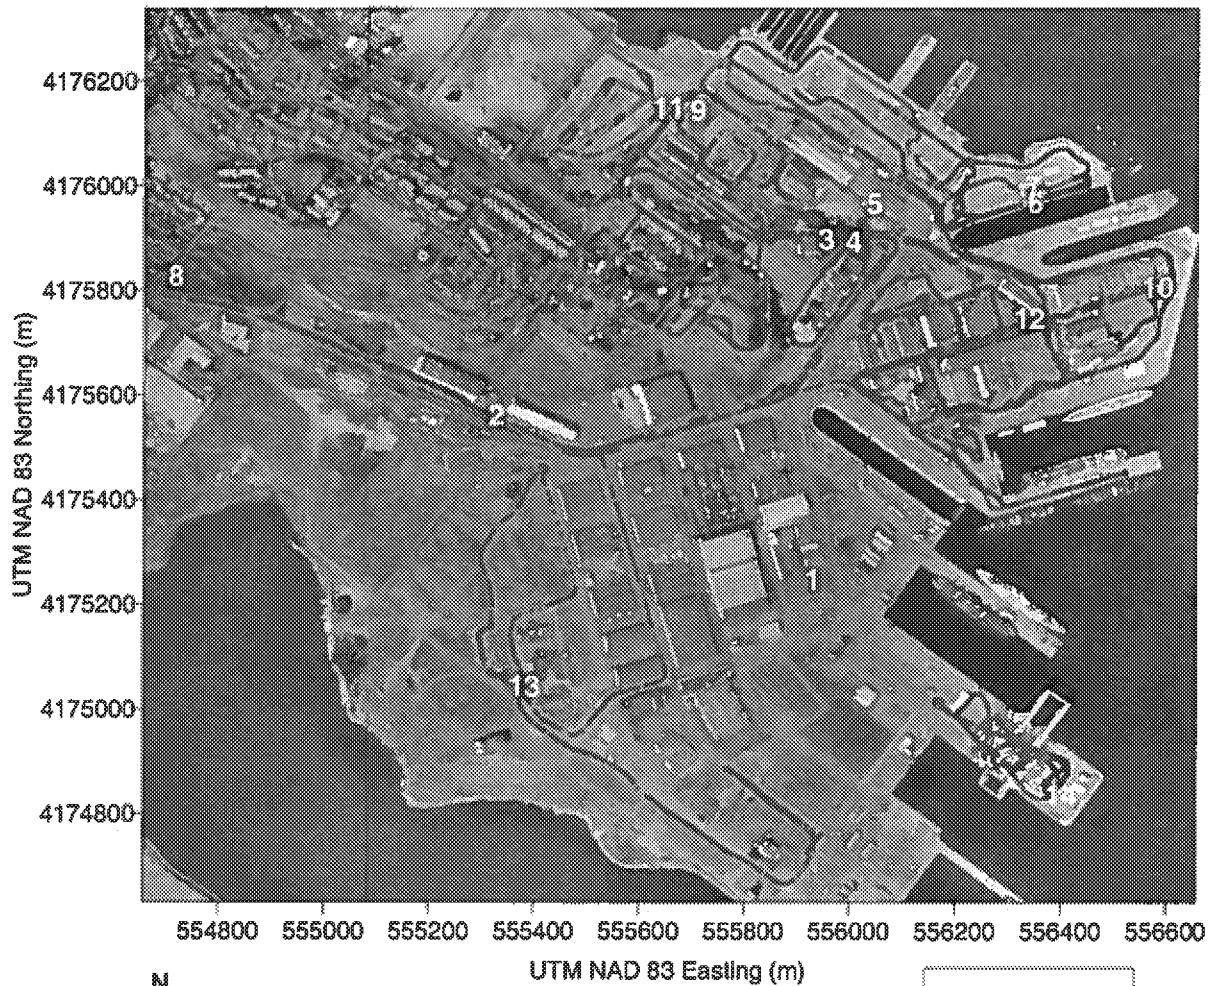
## Main Detector

- 1) Calibration and Setup Location (Not an Anomaly)
- 2) Crisp Avenue
- 3) Robinson Street
- 4) Robinson Street at Horne Avenue
- 5) Lockwood Street near Fisher Avenue (Bldg 134)
- 6) North Side of Drydock #1 (North of Bldg 140)
- 7) North Side of Drydock #1 (South of Bldg 140)
- 8) Griffith Street at Crisp Avenue Gate (Old Main Gate)
- 9) Lot Near Building 117
- 10) Spear Avenue (Bldg 231 and 211)
- 11) Open Field North East of Donahue Street
- 12) Spear Avenue (Bldg 253)
- 13) J Street (Bldg 708)
- 14) End of Pier Under Large Overhead Crane

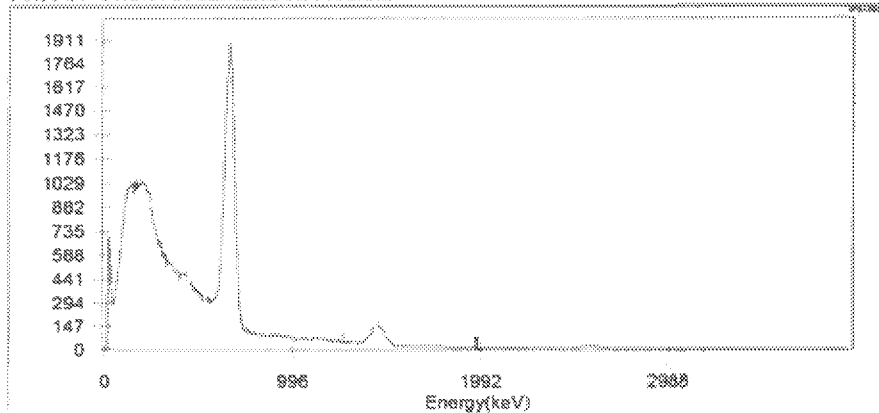
PIIA #1 File: 090902MainPIIA408.cnf

Shows  
Cs-137 Calibration  
Std and Natural  
K-40, Ra-228, and  
Th-232 Peaks.

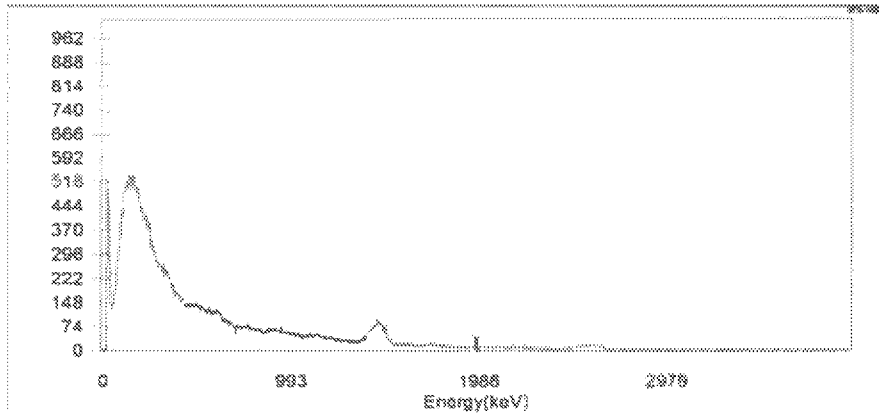
PIIA #2 File: 090902MainPIIA435.cnf

Shows  
Natural K-40, Ra-  
228, and Th-232  
Peaks.

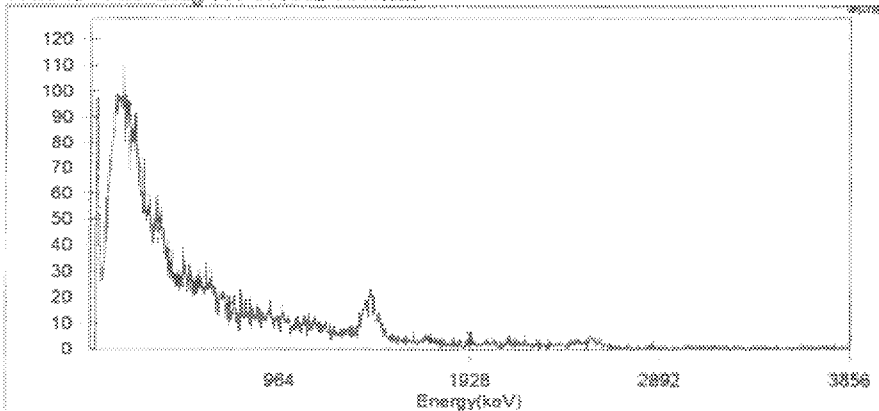
PIIA #3 File: Bldg 111 091002 0847.cnf

Shows  
Natural K-40, Ra-  
228, and Th-232  
Peaks.

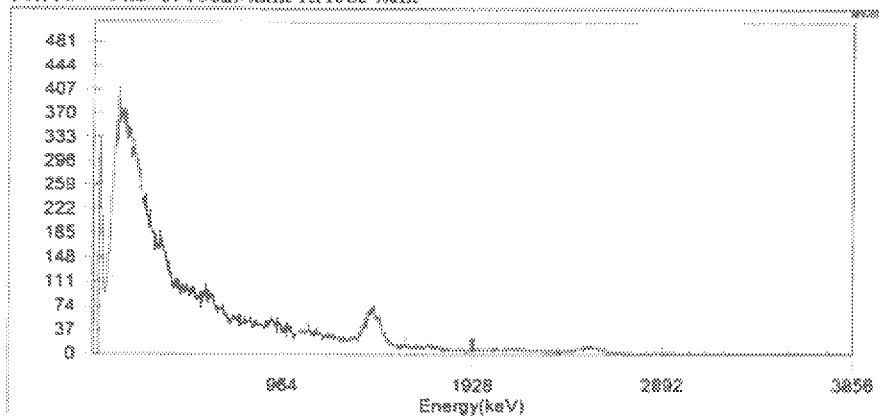
PHA #4 File: 091002MainPHA0854.cnf

Shows  
Natural K-40, Ra-  
228, and Th-232  
Peaks.

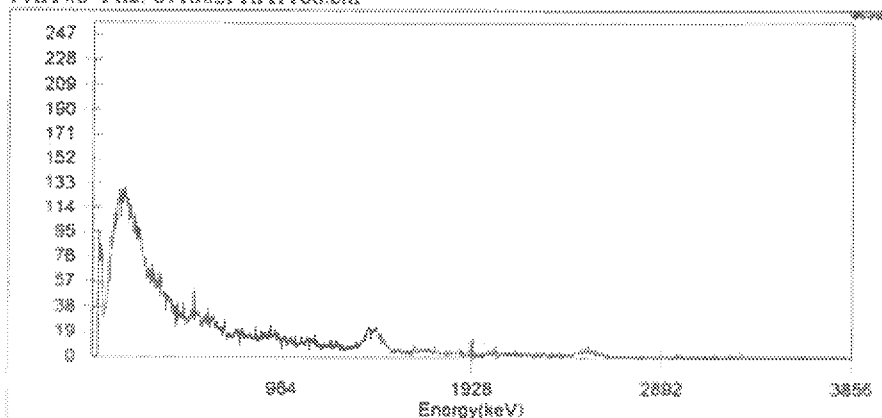
PHA #5 File: 091002PHA1106.cnf

Shows  
Natural K-40, Ra-  
228, and Th-232  
Peaks.

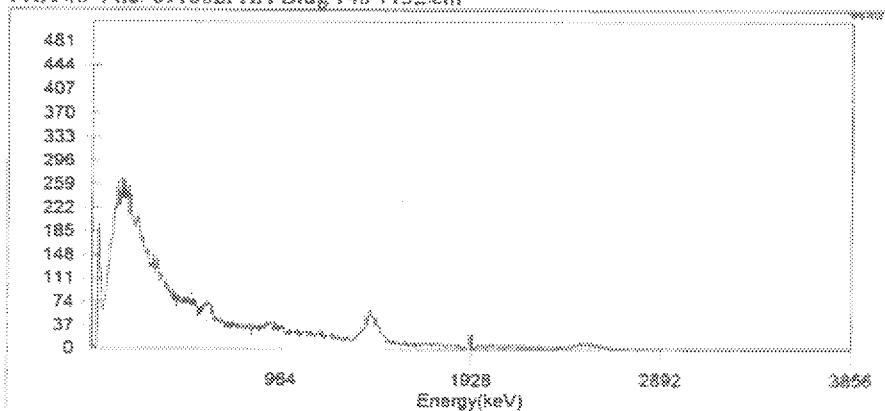
PHA #6 File: 091002PHA Bldg 140 1152.cnf

Shows  
Natural K-40, Ra-  
228, and Th-232  
Peaks.

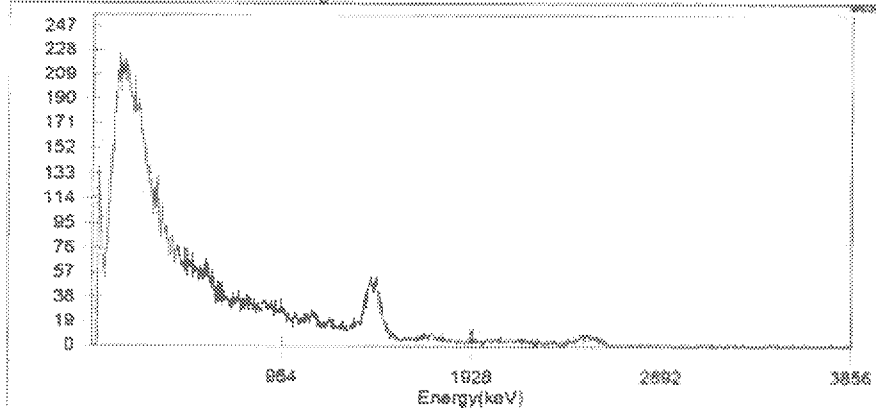
PHA #7 File: 091002PHA Bldg 140 North 1159.cnf

Shows  
Natural K-40, Ra-  
228, and Th-232  
Peaks.

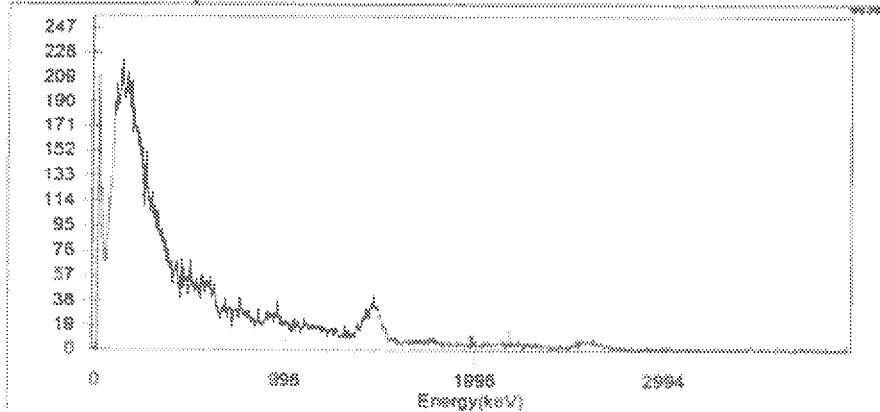
PHA #8 File: Navy Rd 091002 Main PHA.cnf

Shows  
Natural K-40, Ra-  
228, and Th-232  
Peaks.

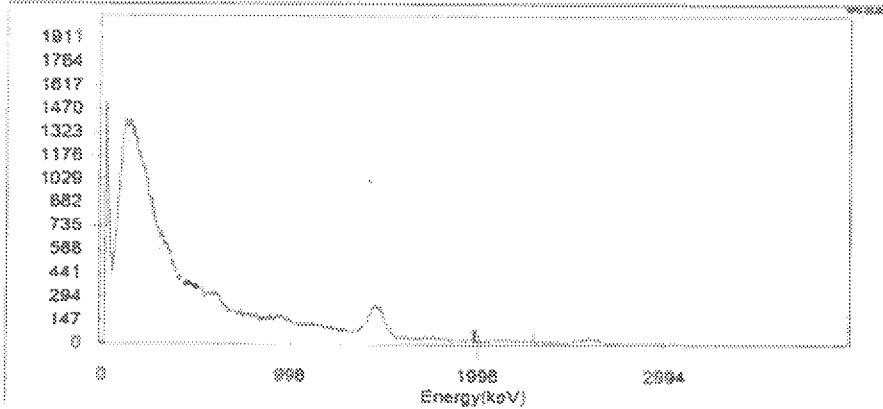
PHA #9 File: Area B Art 091002 PHA Main 1500.cnf

Shows  
Natural K-40, Ra-  
228, and Th-232  
Peaks.

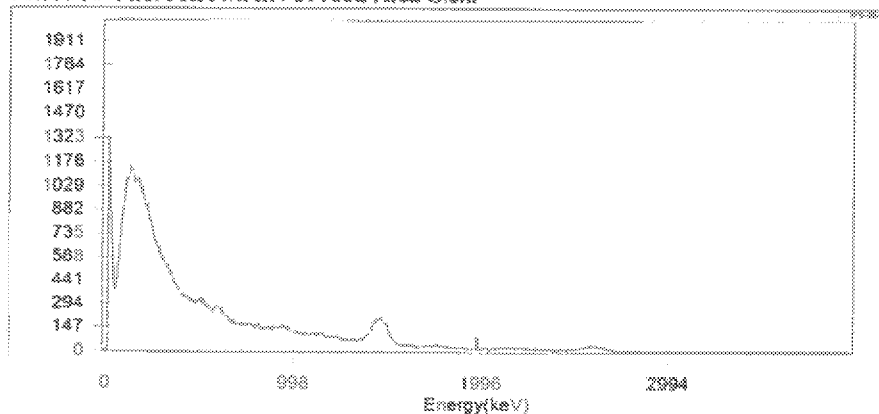
PHA #10 File: PHA MAIN 091002 Area C.cnf

Shows  
Natural K-40, Ra-  
228, and Th-232  
Peaks.

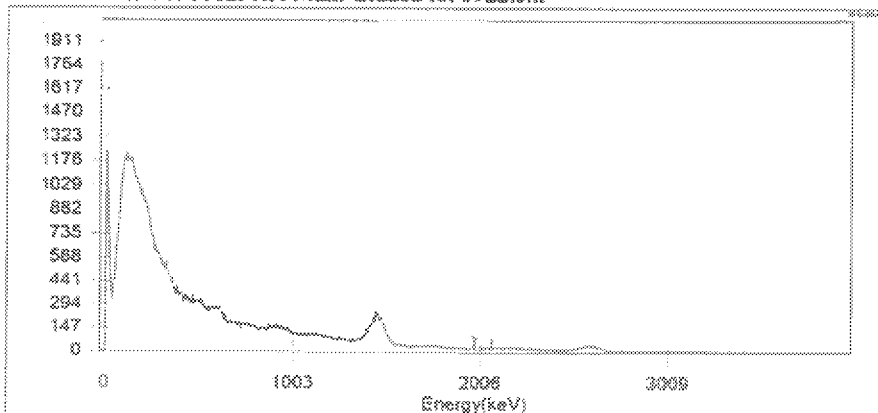
PHA #11 File: 091102PHA Main Graded lot 0922.cnf

Shows  
Natural K-40, Ra-  
228, and Th-232  
Peaks.

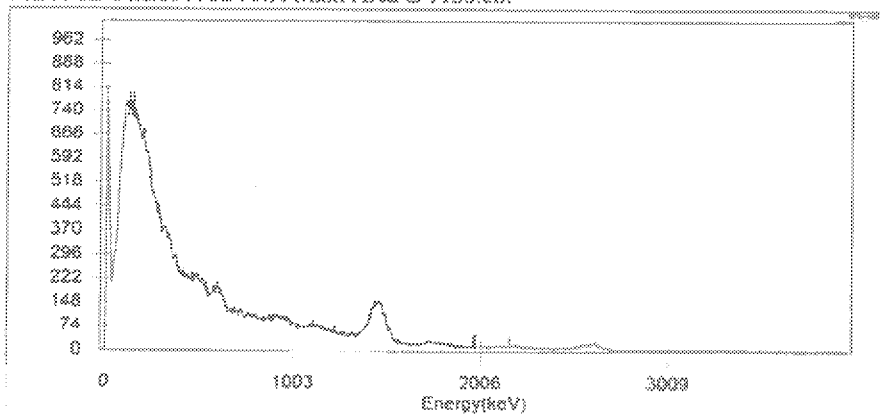
PHA #12 File:091102 PHA Main Area C 1130.cnf

Shows  
Natural K-40, Ra-  
228, and Th-232  
Peaks.

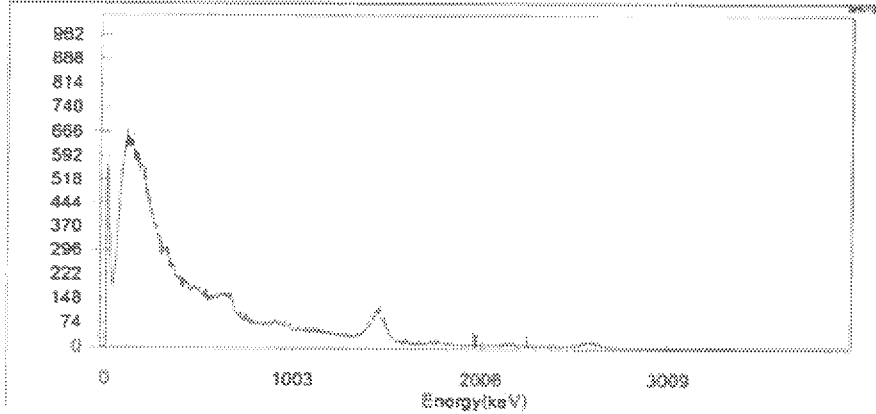
PHA #13 File: 091102 Main Kennel 1230.cnf

Shows  
Natural K-40, Ra-  
228, and Th-232  
Peaks.

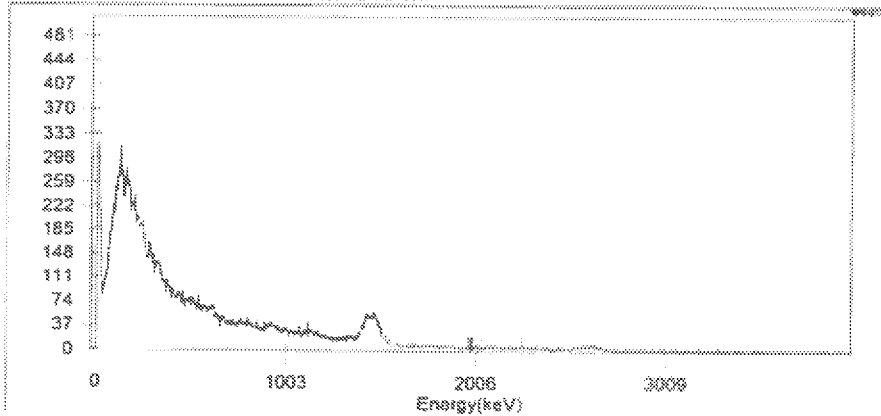
PHA #14 File: 091102PHAMain 1306.cnf

Shows  
Natural K-40, Ra-  
228, and Th-232  
Peaks.

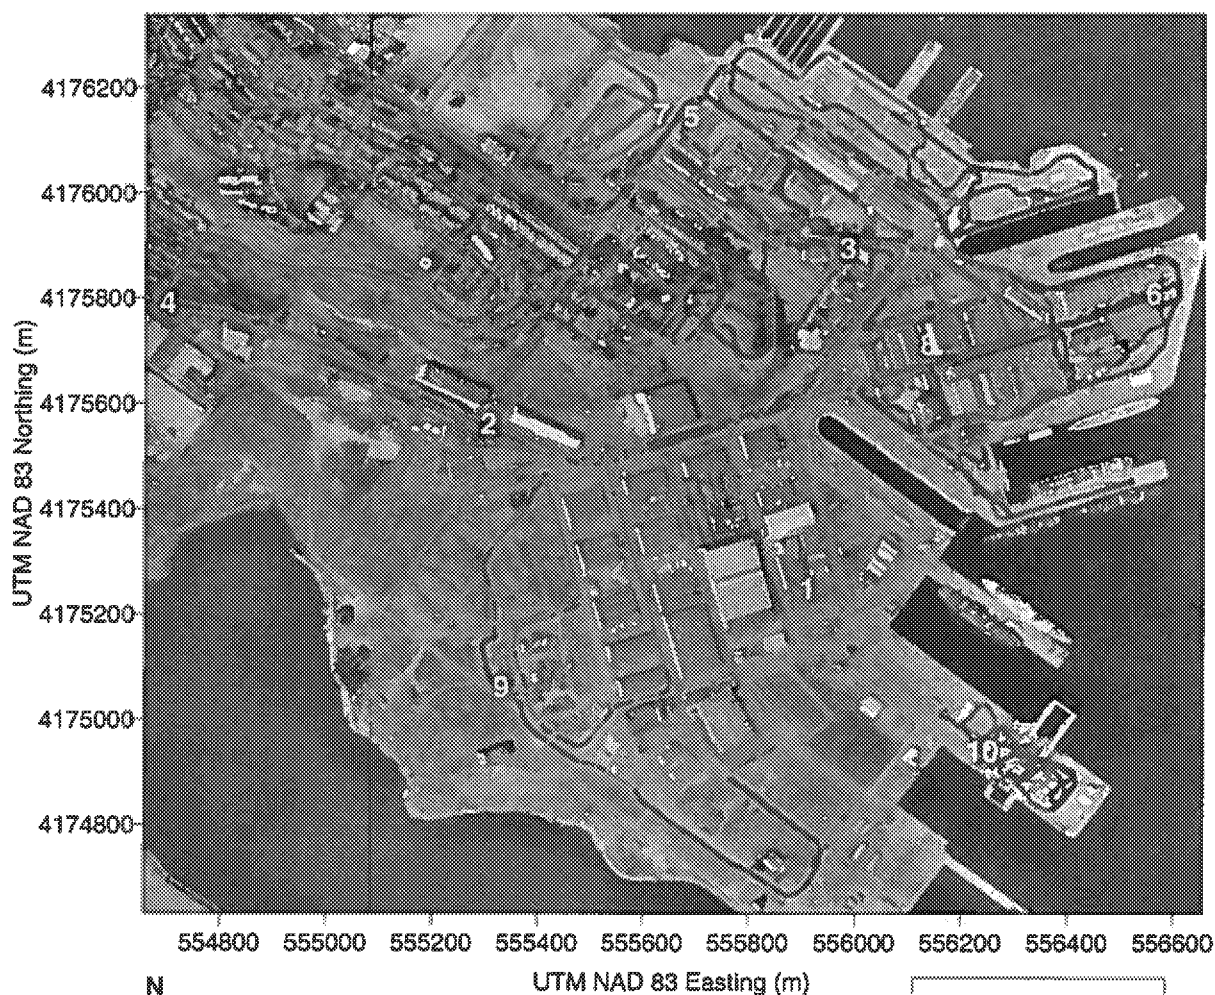
# Gamma Scan of Hunters Point Ship Yard San Francisco, CA Unshielded Detector

- 1) Calibration and Setup Location (Not an Anomaly)
- 2) Crisp Avenue
- 3) Robinson Street
- 4) Griffith Street at Crisp Avenue Gate (Old Main Gate)
- 5) Lot Near Building 117
- 6) Spear Avenue (Bldg 231 and 211)
- 7) Open Field North East of Donahue Street
- 8) Spear Avenue at C Street (Bldg 258)
- 9) J street between 3<sup>rd</sup> and 6<sup>th</sup> Avenue (Bldg 708)
- 10) Under Large Overhead Crane (Near Police Sub-Station)

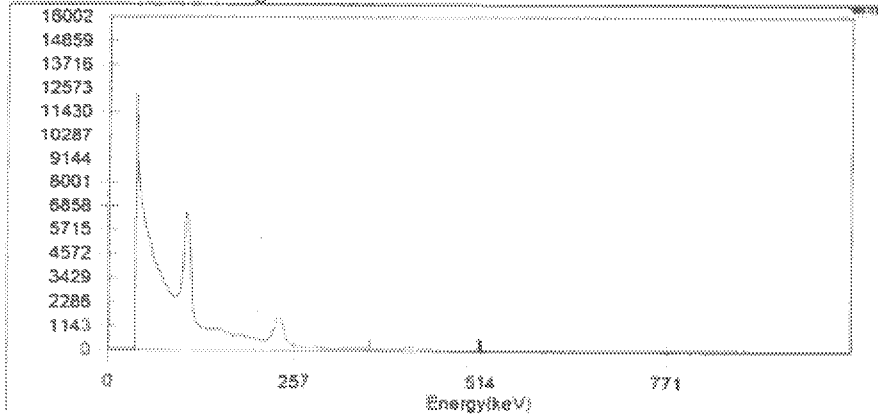
PHA #1 File: 090902Bkgd PHA 408.cnf

Shows Cs-137  
 Check Source and  
 Natural K-40, Ra-  
 228, and Th-232  
 Peaks.(Energy Scale  
 not Calibrated)

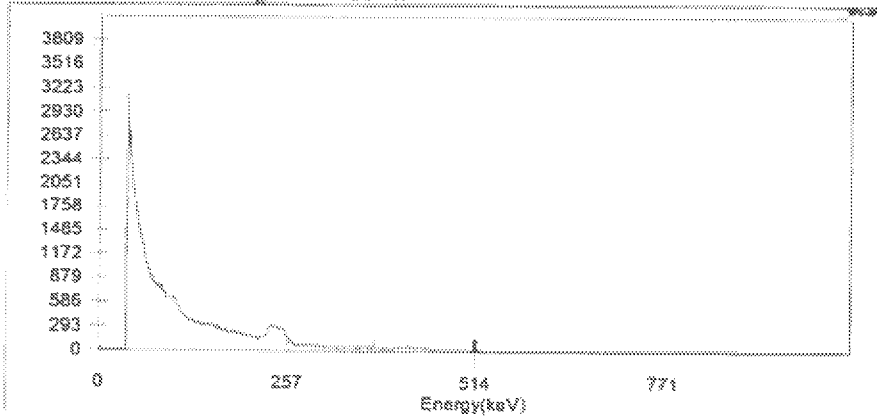
PHA #2 File: 090902Bkgd PHA 435.cnf

Shows  
 Natural K-40,  
 Ra-228, and Th-  
 232 Peaks.  
 (Energy Scale not  
 Calibrated)

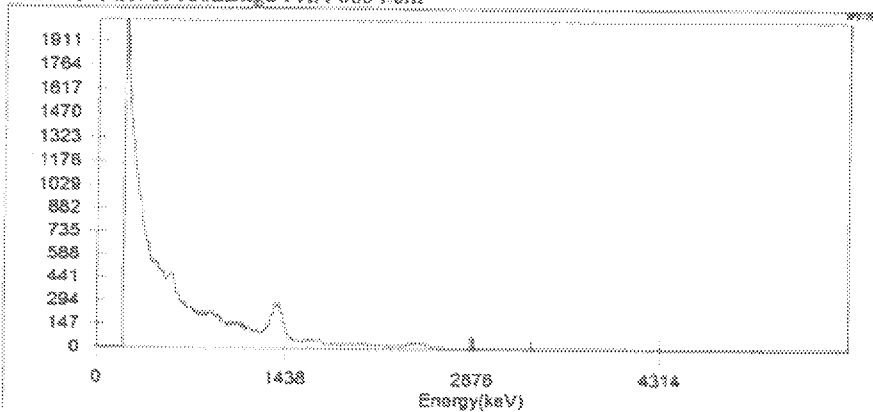
PHA #3 File: 091002Bkgd PHA 0854.cnf

Shows  
 Natural K-40,  
 Ra-228, and Th-  
 232 Peaks.  
 (Energy Scale not  
 Calibrated)

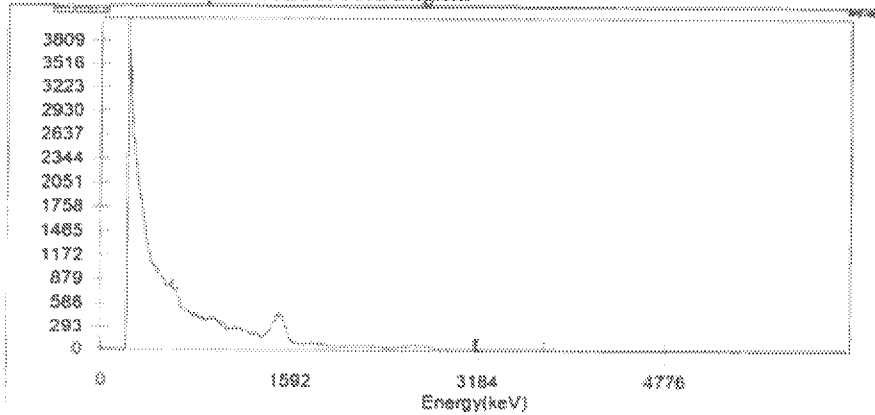
PHA #4 File: Navy Rd PHA 091002 Bkg.cnf

Shows  
 Natural K-40, Ra-  
 228, and Th-232  
 Peaks.

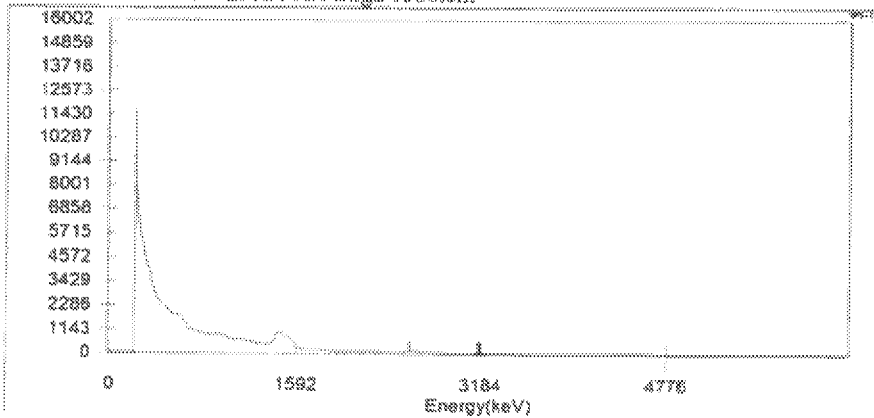
PHA #5 File: 091002PHA Art Bkgd 1500.cnf

Shows  
 Natural K-40, Ra-  
 228, and Th-232  
 Peaks.

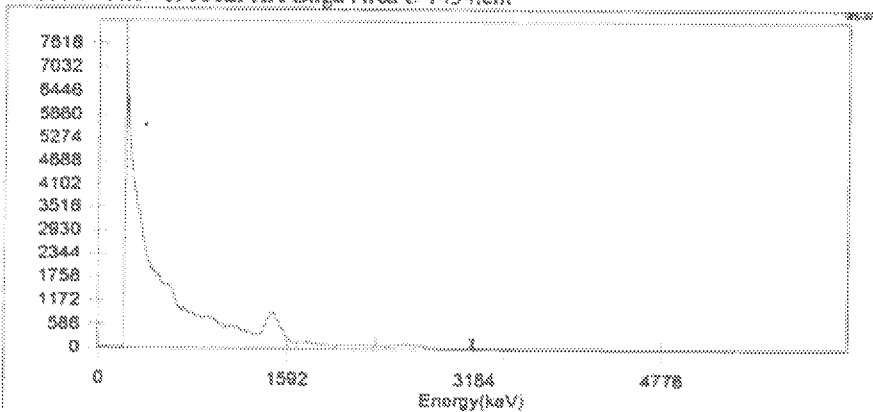
PHA #6 File: 091002PHA Bkgd Area C 1434.cnf

Shows  
 Natural K-40, Ra-  
 228, and Th-232  
 Peaks.

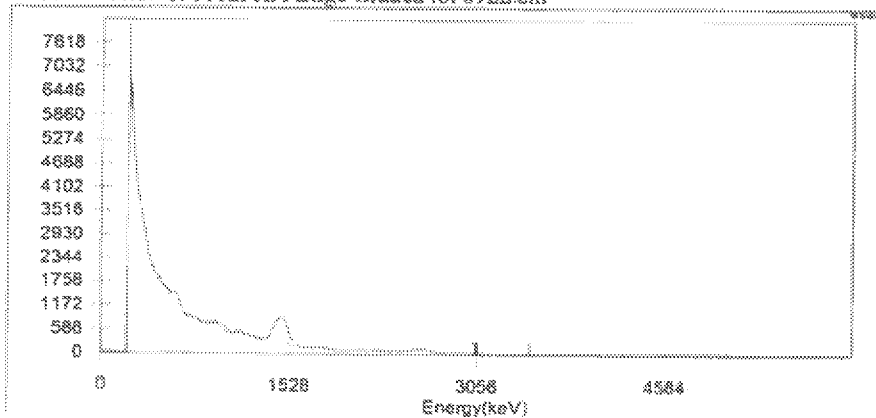
PHA #7 File: 091102PHA Bkge Graded lot 0922.cnf

Shows  
Natural K-40, Ra-  
228, and Th-232  
Peaks.

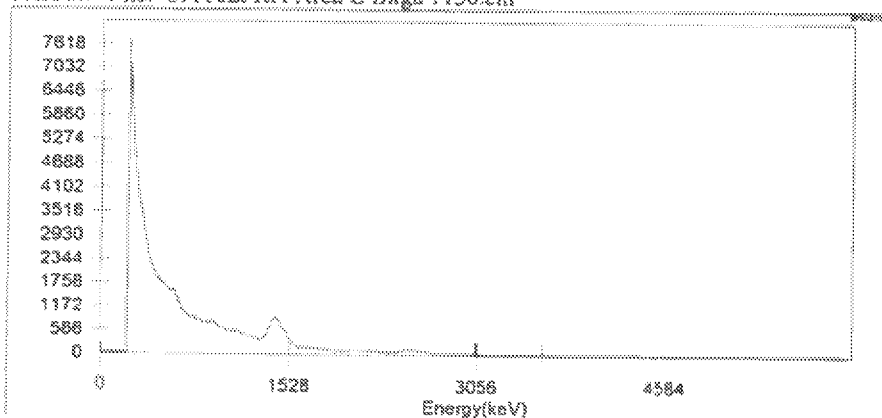
PHA #8 File: 091102PHA Area C Bkgd 1130.cnf

Shows  
Natural K-40, Ra-  
228, and Th-232  
Peaks.

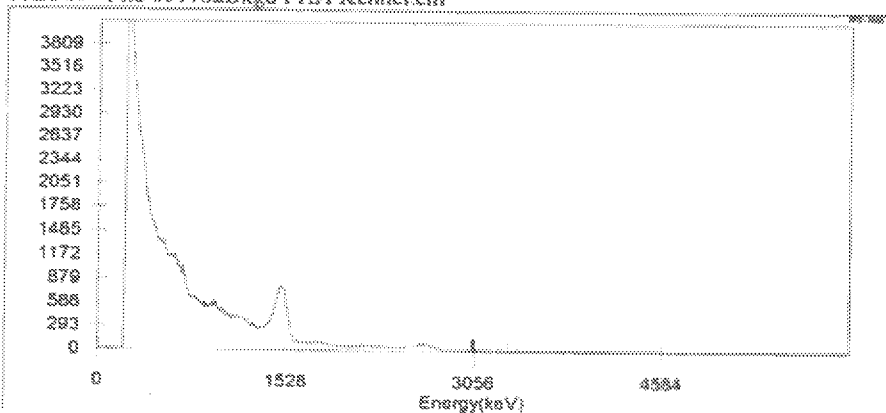
PHA #9 File 091102Bkgd PHA Kennel.cnf

Shows  
Natural K-40, Ra-  
228, and Th-232  
Peaks.

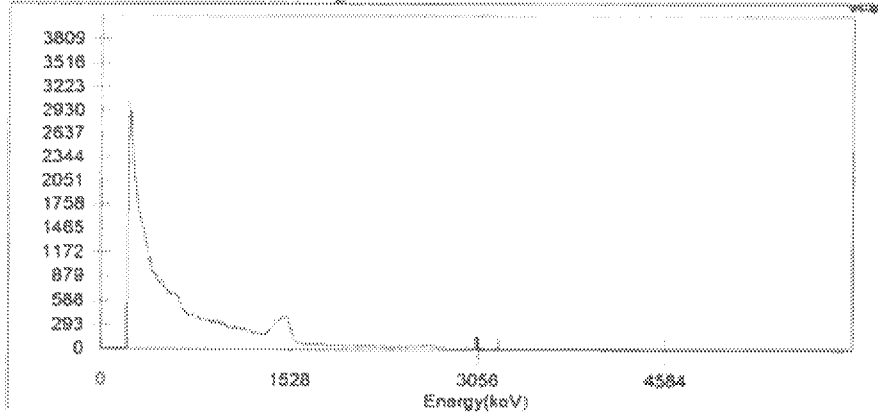
PHA #10 File: 091102PHA Bkgd 1306.cnf

Shows  
Natural K-40, Ra-  
228, and Th-232  
Peaks.
